Vasa föremål

Dokumenterad av EA		Datum 1 april 2014	Föremål axe	Fyndnummer 19953
-----------------------	--	-----------------------	----------------	---------------------

Däck/deck mop	Sida/side port	Balk/beam 4-5	Kanonport/gunport
------------------	-------------------	------------------	-------------------

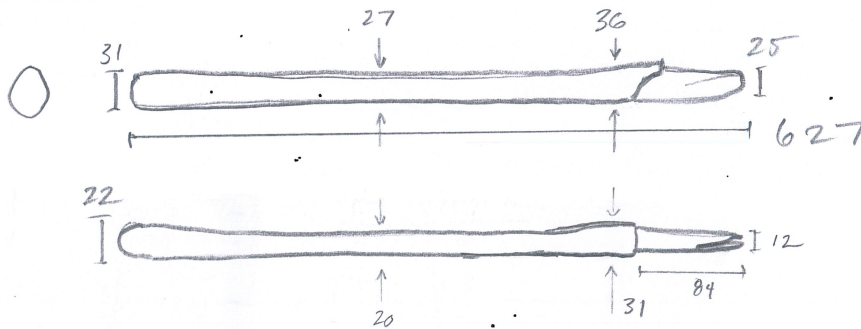
Skiss

Skador/damage in very good condition overall - some surface erosion, but almost no apparent distortion. some splitting @ head likely from wedge (no evidence wedge is still in place)

Kommentar/comments Carve ax handle: evidence of tool marks obscured by pegs erosion - oval, tapers @ head end, steps down to receive head. v. clear hatch marks on one face. 4 sided split @ head end suggests wedge.

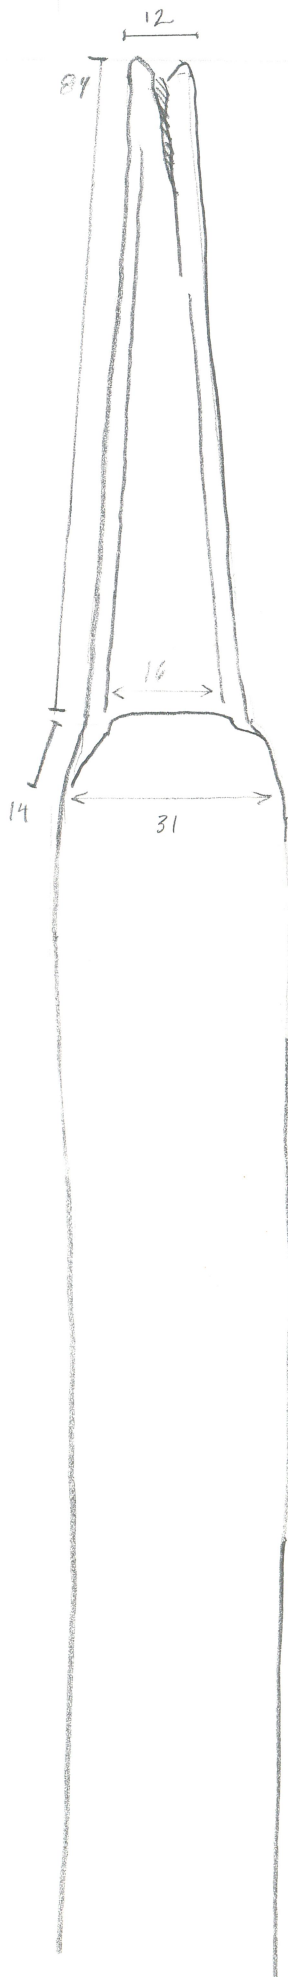
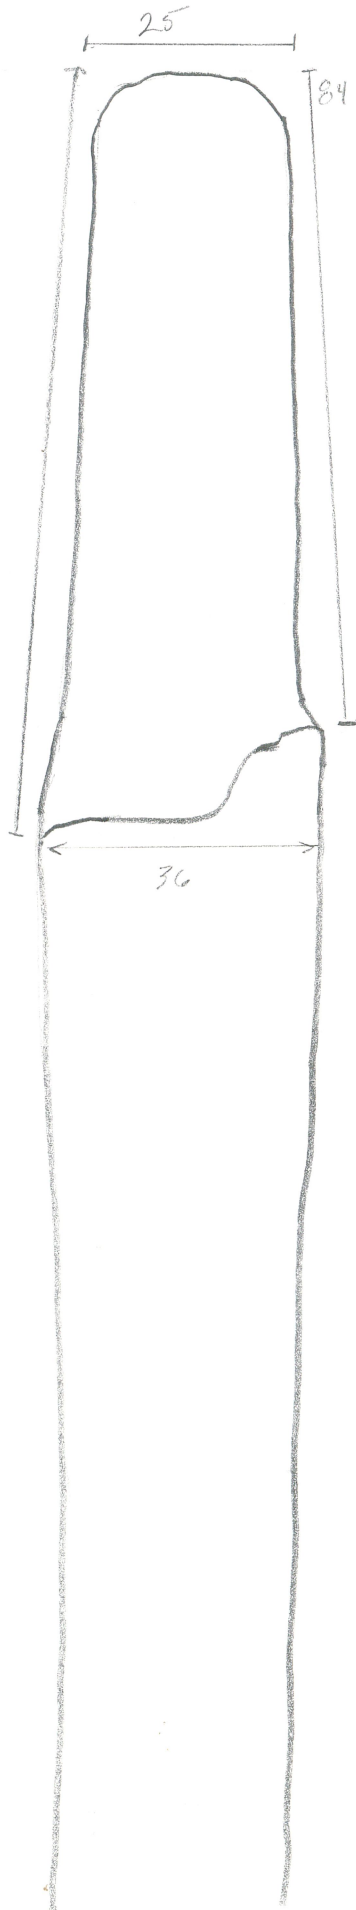
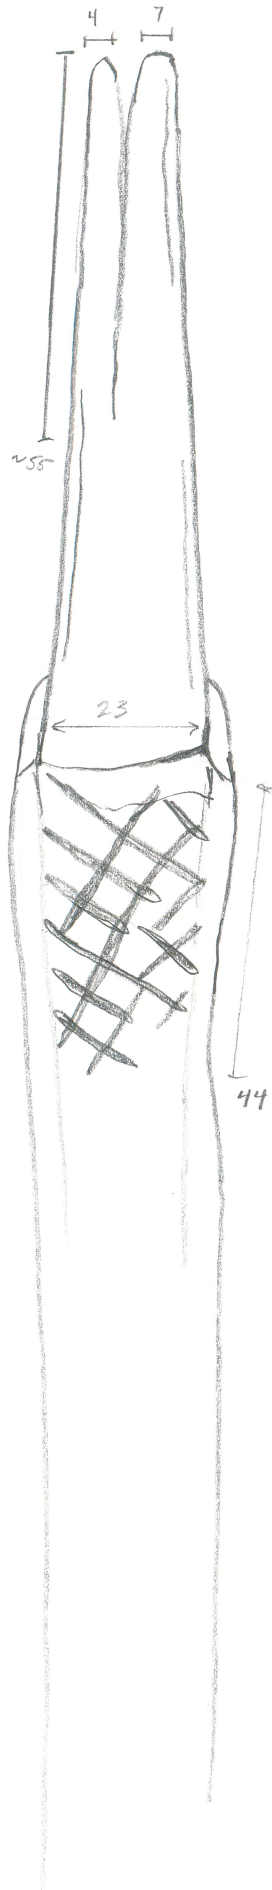
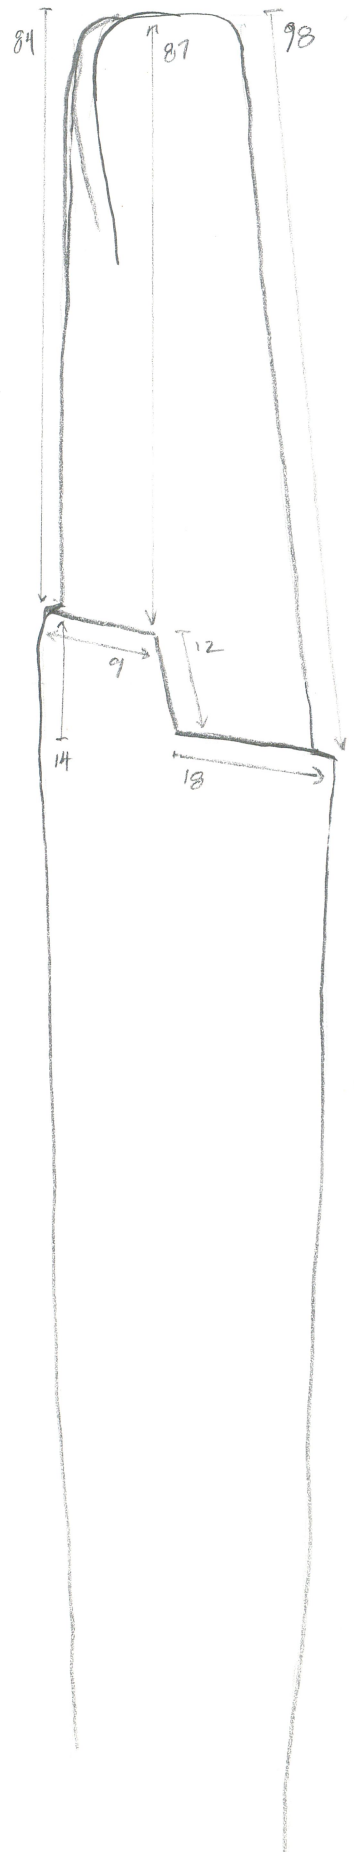
Tool
19953
1 April 2014
R 1/2

★ surface: note hatch marks (photo flag)

★ ans note: can we clean to clarify detail @ head?
