Vasa föremål

Caulking
Mallet

18460

Ship's Carpenters Tools
18460
11 Nov 2013 EAA

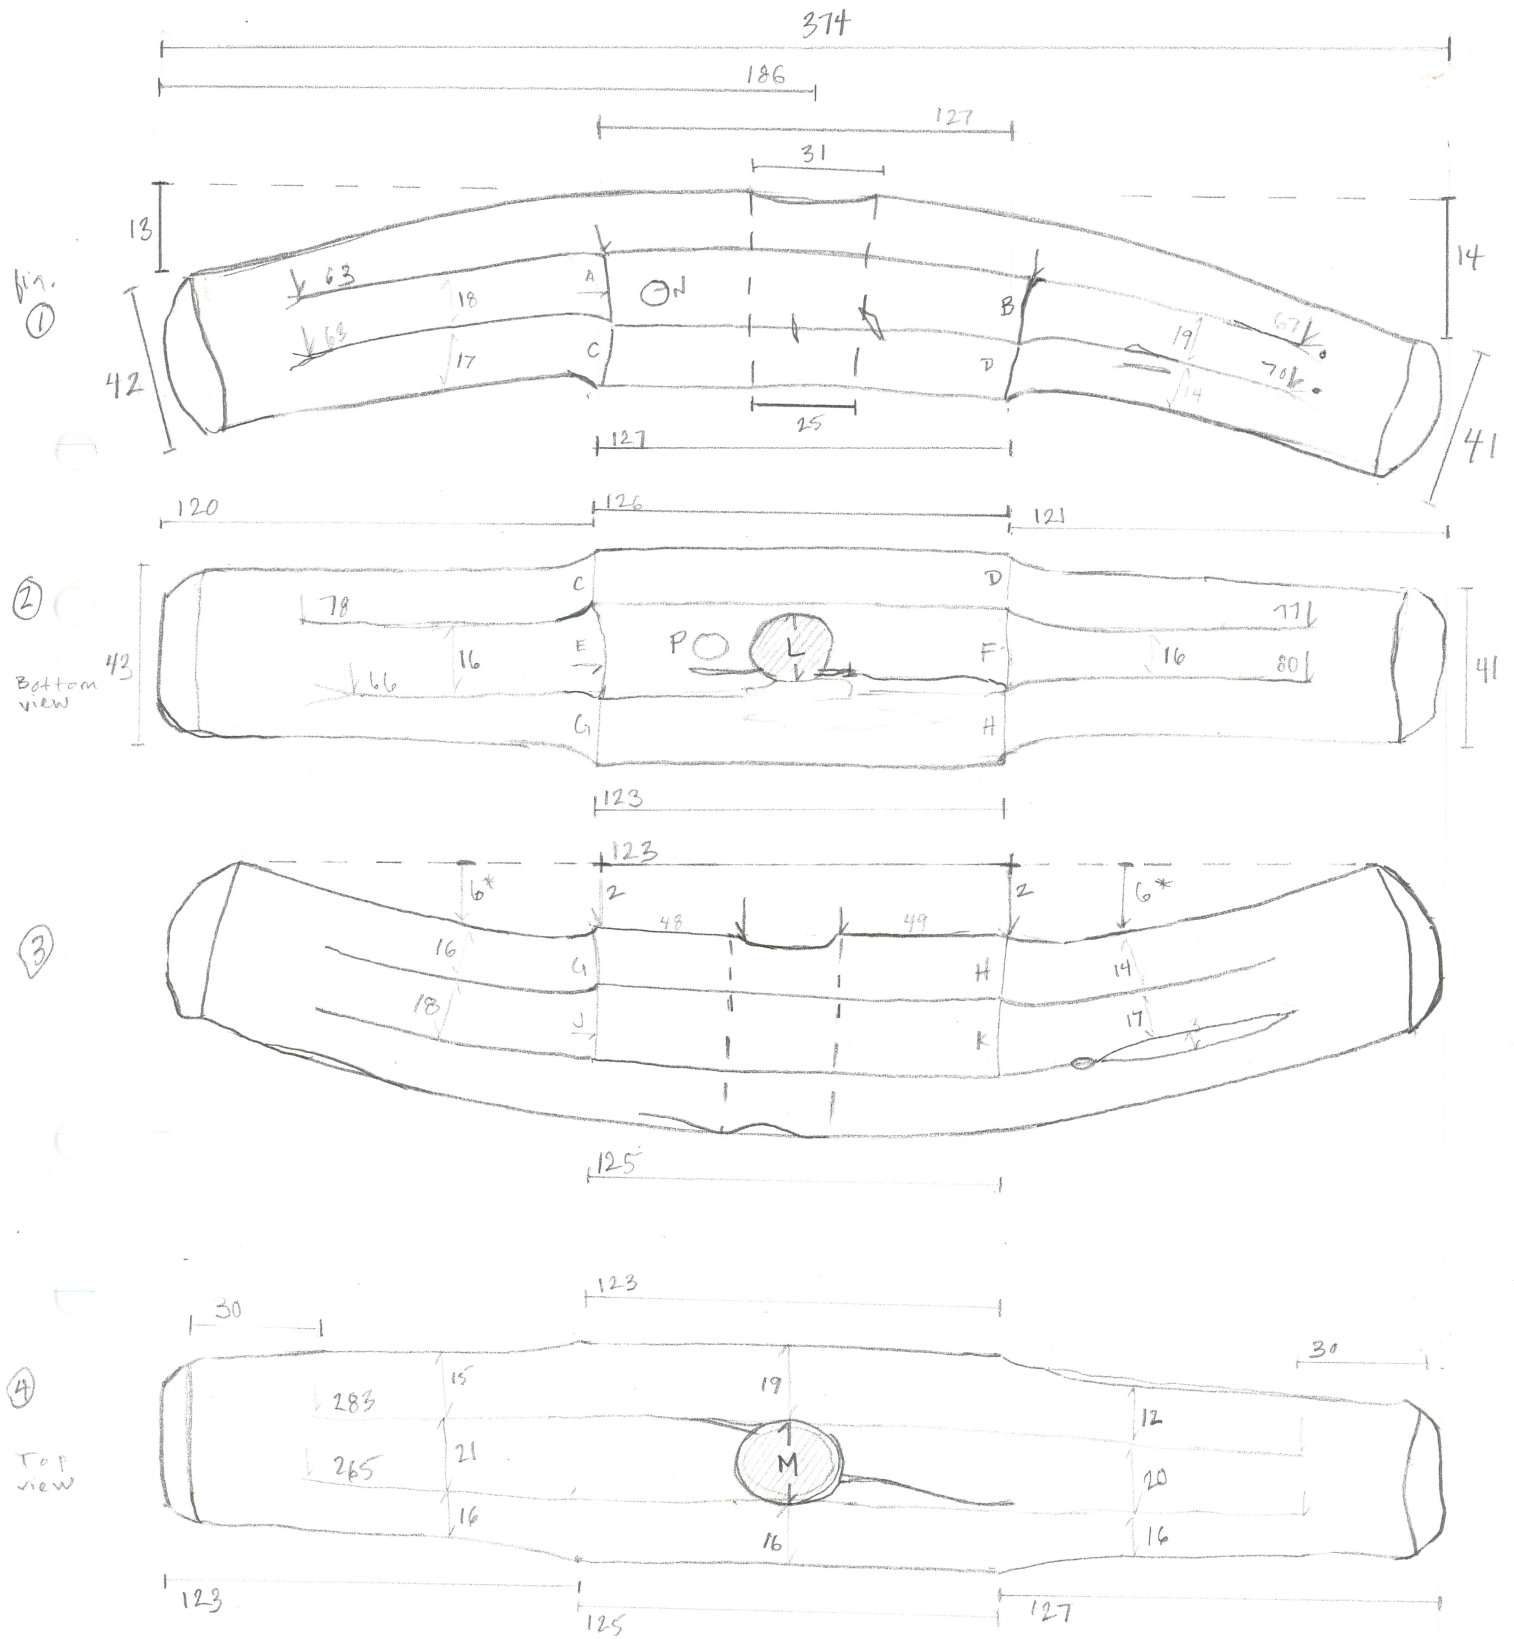
18460 caulking Mallet head

Skador/damage some loss on underside @ "X" (around hole for handle) original surface largely intact; mushrooming/grain compression @ ends indicates mallet had been used.

Kommentar/comments blind holes @ Right end modern, artifacts of tagging. two plugged blind holes on face & bottom. Purpose not immediately apparent.

Visible evidence that the ends of the mallet had metal rings to prevent splitting during use; have completely corroded, no extant metal

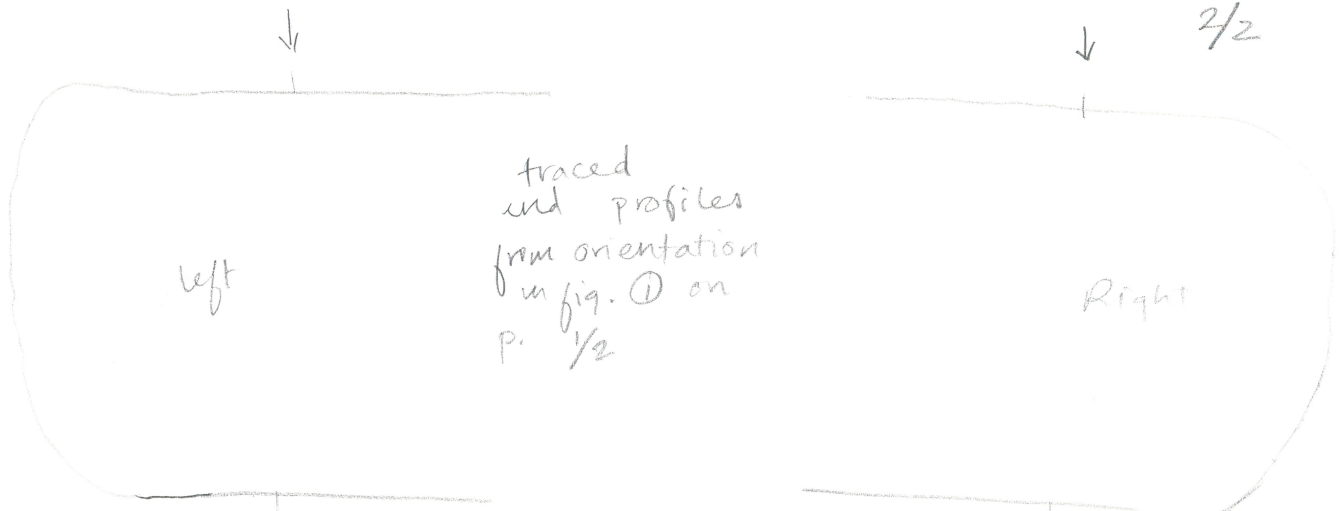
18460 caulking Mallet Head

compression from nwg starts here
