## The Maderö wreck: a ship loaded with bricks from Lübeck sunk in the Stockholm Archipelago in the late 15th century

Niklas Eriksson, Torbjörn Brorsson, Aoife Daly, Jim Hansson & Sven Isaksson

The Maderö wreck was discovered in the 1960s in the Stockholm Archipelago, Sweden. An archaeological investigation undertaken in 2022 included the inspection and documentation of visible ship parts, sampling for dendrochronological analysis and sampling for ICP analysis from the brick cargo. The results show that the wood originates from the Baltic Sea area and was felled after 1467, while the clay for the brick originates from the Mecklenburg-Vorpommern area. The ship's technical analysis shows that it is a large clinker-built merchant ship. Traces of iron on a recovered stone shot indicate that the ship was armed when it sank.

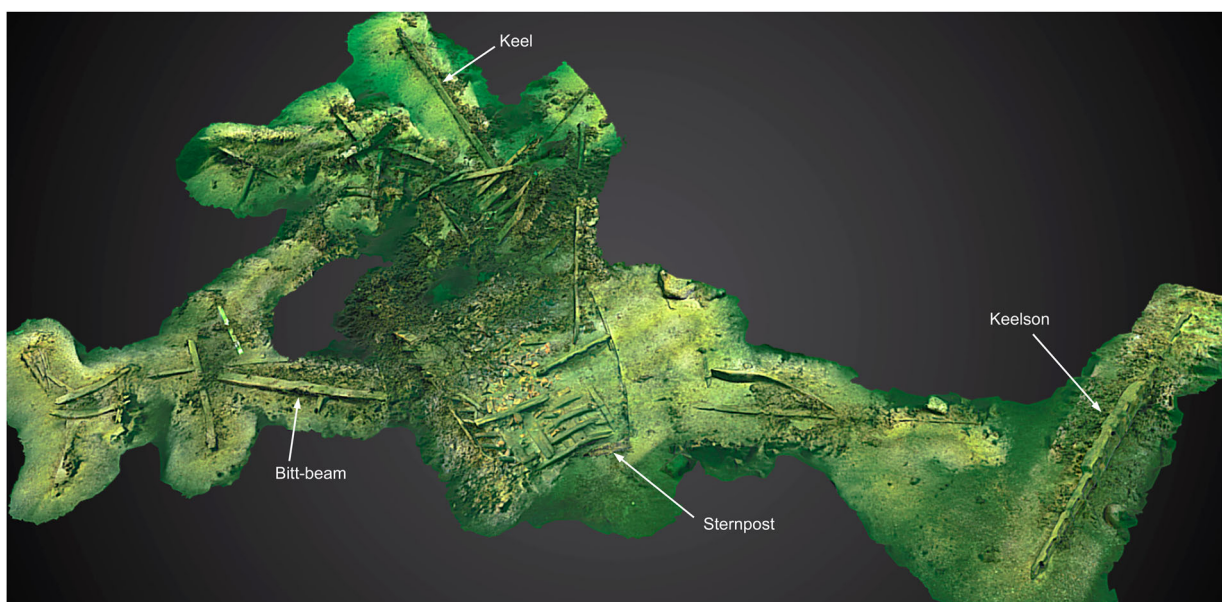
**Figure 2.** Photogrammetric model of the dramatic Maderö wreck. The foremost end of the keel rests in 17 m of water whereas the stern is located at 22 m. Due to limited time the fieldwork photography was concentrated in the areas with ship timbers, leaving out the empty spaces of seabed in between (Jim Hansson/SMTM).

The Maderö wreck rests on a slope with the bow pointing diagonally towards the shoreline of the Maderö island, hence the wreck's working name (Figure 3). The bow has totally disintegrated but the keel is preserved in its entire length. The foremost end of the keel is located in 17 m of water whereas the depth at the stern is 23 m. Astern of the wreck the seabed slopes down to more than 30 m, which means that parts of the now disintegrated bow might have fallen down towards the stern, but also that parts of the vessel may be located

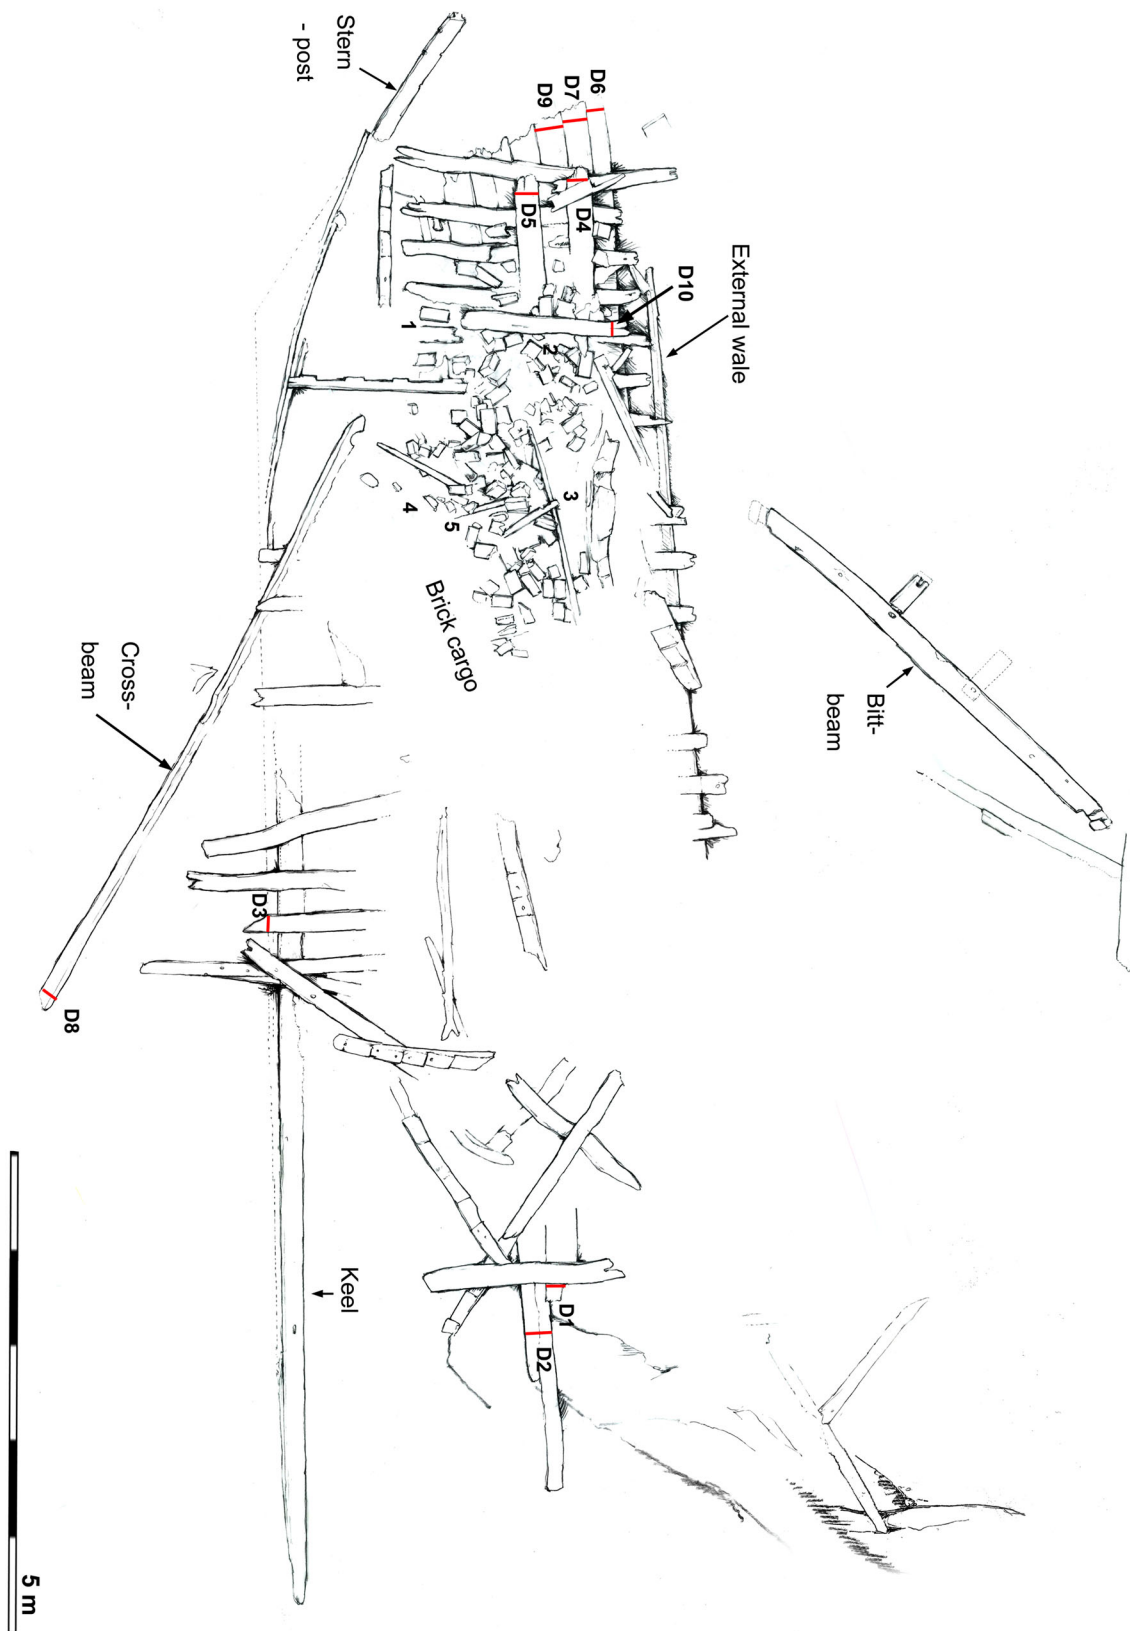
**Figure 4.** Plan of the coherent hull structure with the bow pointing to the right. The numbers correspond to the dendro samples; D1 and D2 are samples from tangentially converted hull planks whereas D6, D7 and D9 are radially converted hull planks; D4 and D5 are ceiling planks; D3 is a floor timber; and D8 is probably a crossbeam. The five samples used for ICP analyses: 1, 3 and 4 are tiles, whereas 2 and 5 are bricks (Niklas Eriksson).

the Maderö wreck are still intact (compare Figure 4). All observed timbers and planks in the hull appear to be made of oak. The forward end of the T-shaped keel rests on an exposed rock and the keel has bent under the weight of the brick cargo. The forward end of the keel has a pronounced scarf, where the lowest end of the stem was attached. Unfortunately the scarf is heavily eroded so it is not possible to determine if it was shaped with a hook or not. The aft end of the

Ten samples for dendrochronological analysis, all oak (*Quercus* sp.), were sawn from the hull structure. The distribution of these samples is shown in Figure 4. Sample 3, which is a floor timber, and sample 8, from the crossbeam, only contained 21 and ca 40 tree rings, respectively, and were not examined further. Samples 4 and 5, which were sawn from the ceiling planks, contained 47 and 45 tree rings, respectively, and sample 10, also a ceiling, contained 54. These three samples, which all derive from the interior of the ship, were analysed through dendrochronology but could not be dated due to the short tree-ring series (Daly, 2022).

were identified dendrochronologically. Two tangentially converted planks form one group while three radial planks indicate a separate group. The samples from the two tangentially converted planks are from the forward part of the preserved hull structure, which means that they were originally placed amidships (D1 and D2 in Figure 4), whereas the samples from the radially converted planks are located near the stern (D6, D7 and D9 in Figure 4).

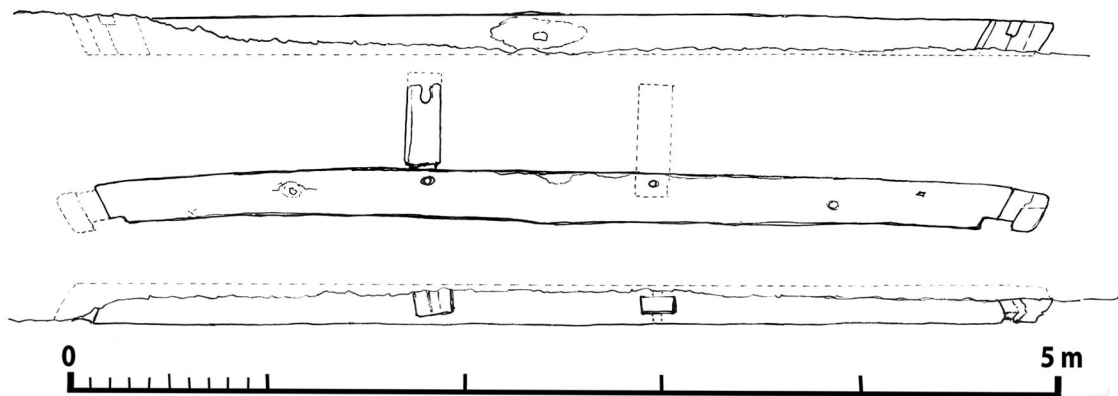
**Figure 5.** The bitt beam discovered loose on the seabed. Note the ends with notches to be secured in the hull planking and the standing bitt (Niklas Eriksson).

The bitt beam was found loose on the seabed just south of the coherent portside (Figure 3 and Figure 5) but the shape and angle of the ends of this timber indicates that it was originally placed towards the forward end of the hull. The ends of the beam also reveal that it has fitted, inset into the hull planking, with the ends protruding through the hull side.

On the upper side of the timbers a short standing bitt is attached in a mortise and secured with a dowel. Another mortise is located in symmetry with this standing bitt, which means that originally there was another short standing timber on the beam. Such bitt beams

are known from several late medieval and early modern ships and are usually located in or just above deck-level in the bow of the ship. The two standing bitts were used to belay the anchor cable. On clinker-built hulls the bitt beams usually protrude from the hull planking, for instance on the Ringaren wreck (Svenwall, 1994, p. 60), a feature also visible on the 15th-century Ebersdorff ship model (Christensen & Steusloff, 2012). Some early carvel-built ship-finds in the Baltic area also reveal protruding bitt beams (Adams, 2013, p. 83; Eriksson, 2015, p. 23). Another example of a carvel-built hull with a protruding bitt beam is the Mataró Model at the Maritime Museum Rotterdam, from around 1450 (De Meer, 2009).

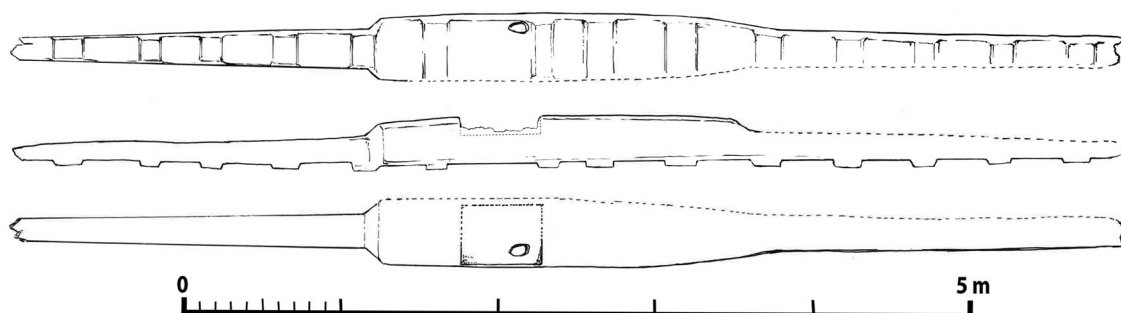
**Figure 6.** The keelson which has been moved since the wreck was discovered in the 1960s (Niklas Eriksson).

As mentioned above, the 7 m-long keelson has been removed since divers first discovered the wreck. The timber was tilted over at some point during the last 15 years and it now rests with the square notch for the mast covered in sediment, though fortunately the square notch was photographed and measured in 2003. The keelson is made from a single piece of oak, around 50 cm wide at the most, narrowing towards both ends and rebated onto the top of the floor timbers (Figure 6).

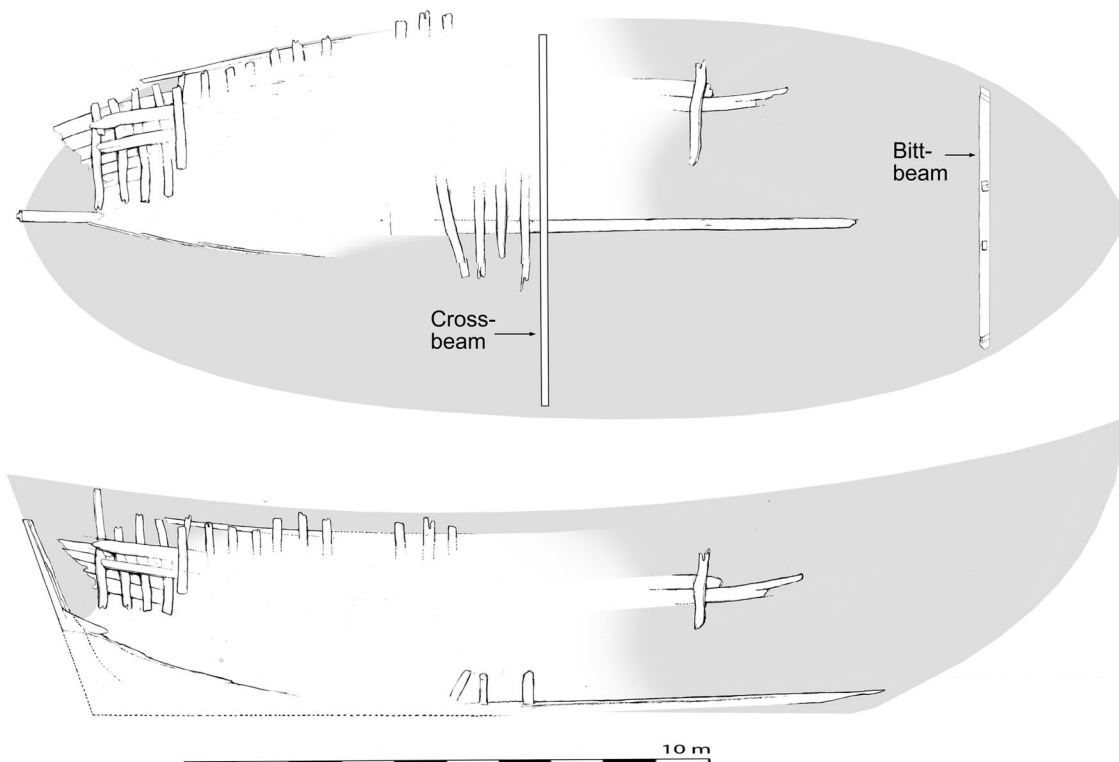
**Figure 7.** Interpretation and reconstruction to visualise the possible original dimensions of the hull and the approximate location of the crossbeam and the bitt beam, compiled from 3D photogrammetry and underwater measurements (Niklas Eriksson).

The only preserved crossbeam was found loose, but as it is 7 m long it appears likely that it was placed in the vicinity of the greatest breadth amidships. The bitt beam was originally located towards the forward end of the hull and thus does not provide information regarding the maximum breadth. Under sediment and the brick cargo, the portside quarter of the hull side is coherent and well preserved. To what extent the hull side has deformed and altered shape is difficult to tell without removing the brick cargo. The impression is that the distortion to the hull side does not appear to be very severe. The aftermost part of the preserved hull side has fallen out slightly, but just aft of amidships the hull appears to have kept its original curvature. At this part the hull is slightly less than 8 m wide, which fits well with the crossbeam's length (compare Figure 7).

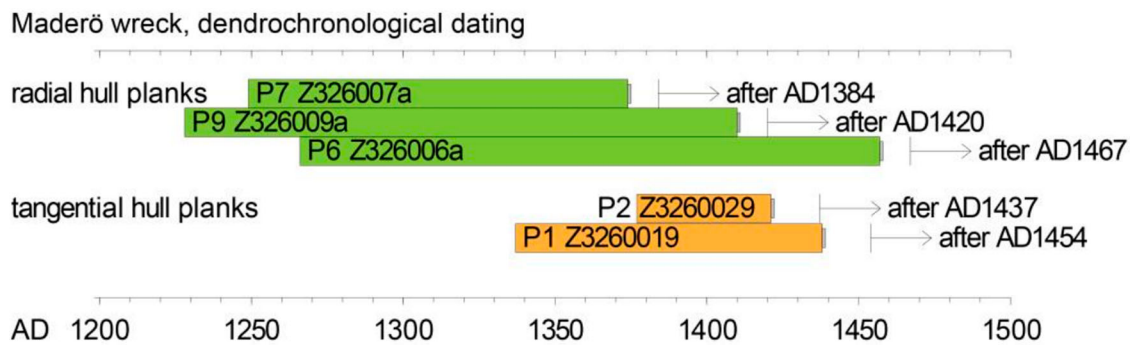
**Figure 8.** The chronological position of the dated samples from the Maderö wreck. The green and orange bars represent the position in time of the preserved tree rings in each sample. No sapwood is preserved on the samples, so the interpretation of the felling date for each sample, allowing for missing sapwood, is indicated with an arrow.

Unfortunately none of the samples contained sapwood. The outermost complete ring is sample 6, which is one of the radially converted planks in the stern. This ring was formed in AD 1457 and one additional partial ring is observed outermost on the sample. Allowing for missing sapwood, the felling of the tree can be placed at after AD 1467. (For estimating the felling date of the oak trees that were used for the radial planks, a sapwood average for northern Poland [15 years  $-6/+9$ ; Wazny, 1990, p. 213] was used). For the two tangential planks, however, we used the slightly longer estimate for northern Germany (*ca* 20 sapwood years  $-5/+10$ ; Hollstein, 1980). As shown in Figure 8, the felling date estimates for the trees that each plank was made from are *terminus post quem*; the dendrochronology does not give a fine enough resolution to allow us to state that they are all parts of the original structure of the ship rather than repairs.

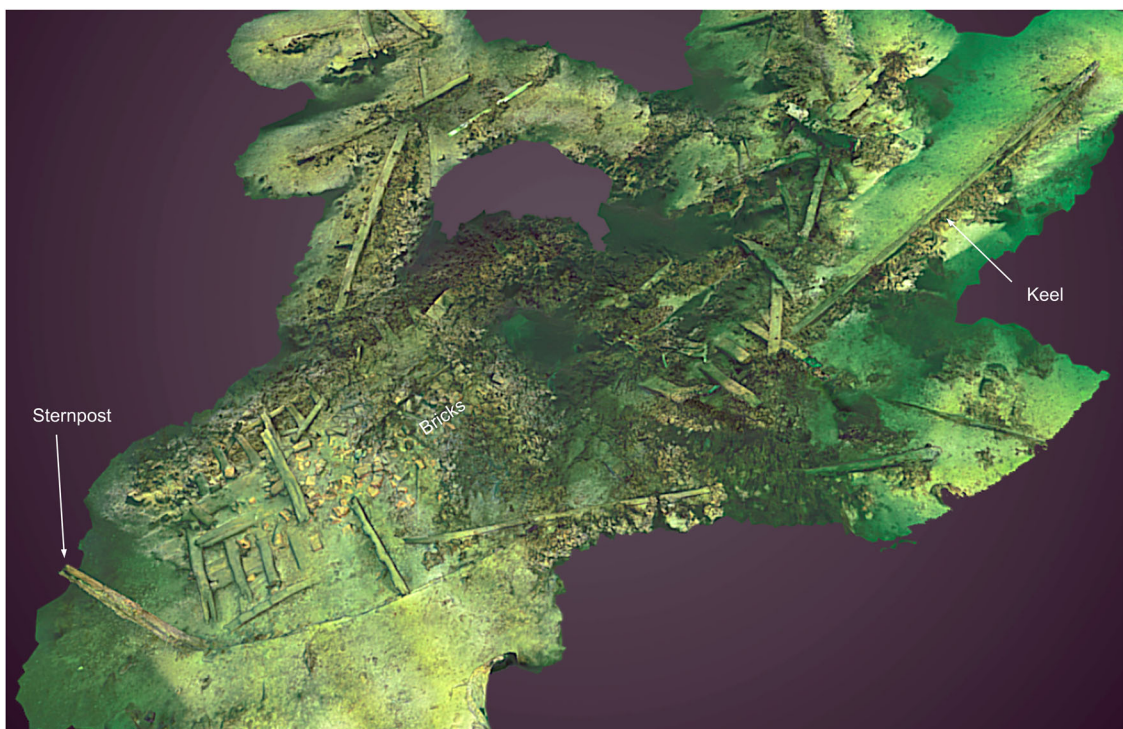
**Figure 11.** The Maderö wreck rests with a list and the bow pointing up towards land, which has caused the brick cargo to slide aft and to port (Jim Hansson/SMTM).

The coherent port side is to a large extent covered by the cargo consisting of a mix of conventional rectangular bricks and specially shaped and profiled bricks used in niches around doors and windows in medieval buildings (Figure 11). Among the cargo

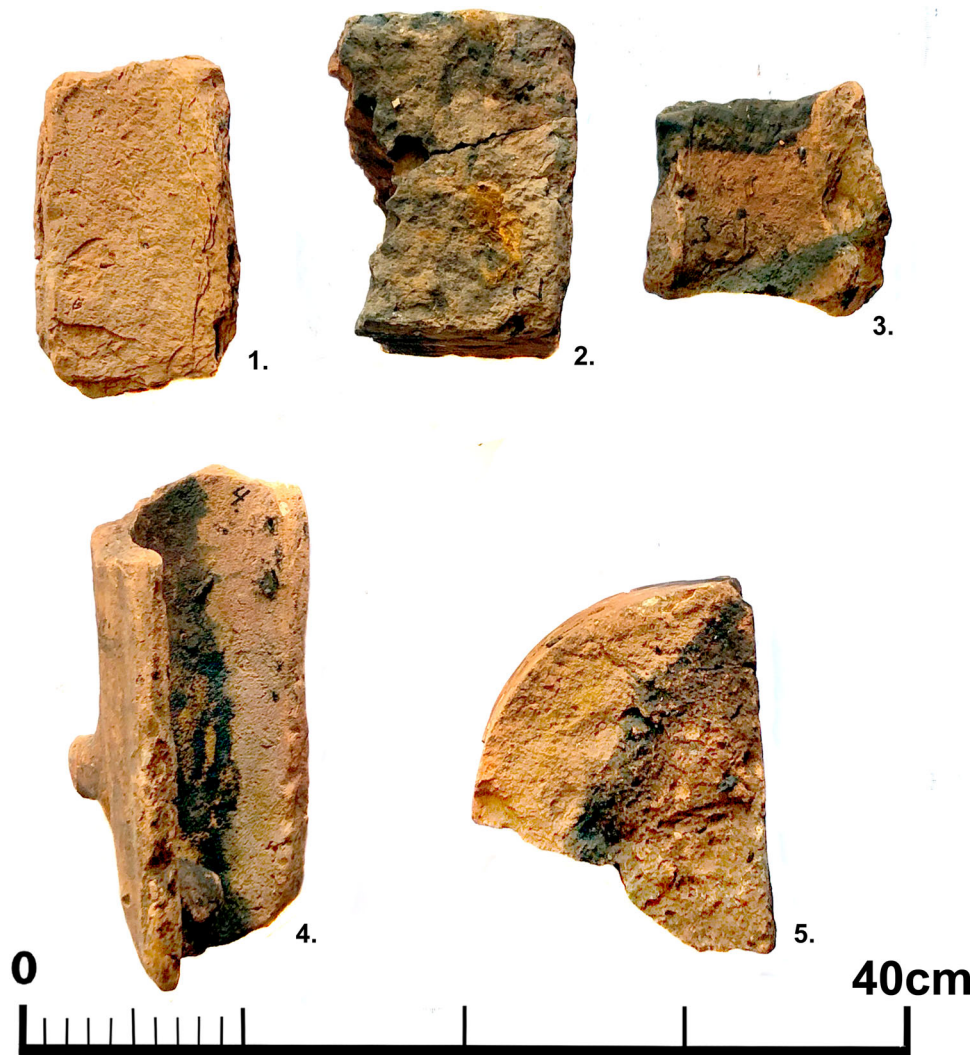
**Figure 12.** Five samples were raised from the cargo to be used for ICP analysis. 1: roof tile; 2: brick; 3: roof tile; 4: roof tile; 5: profile brick. The location of the samples is shown in Figure 4 (Niklas Eriksson).

In order to attain knowledge about the origin of the cargo, five brick samples were analysed (Figure 12). These were selected so that they represent different types of bricks and roof tiles. The samples were analysed through ICP-MA/ES. The aim of this method of analysis is to determine the geographical origin of the clays used for producing pottery, bricks, roof tiles, stove tiles, etc. (see for example Brorsson, 2013; Little et al., 2004). ICP-MA/ES is a chemical analysis that provides information on the chemical identity of a sherd by measuring a vast spectrum of elements down to

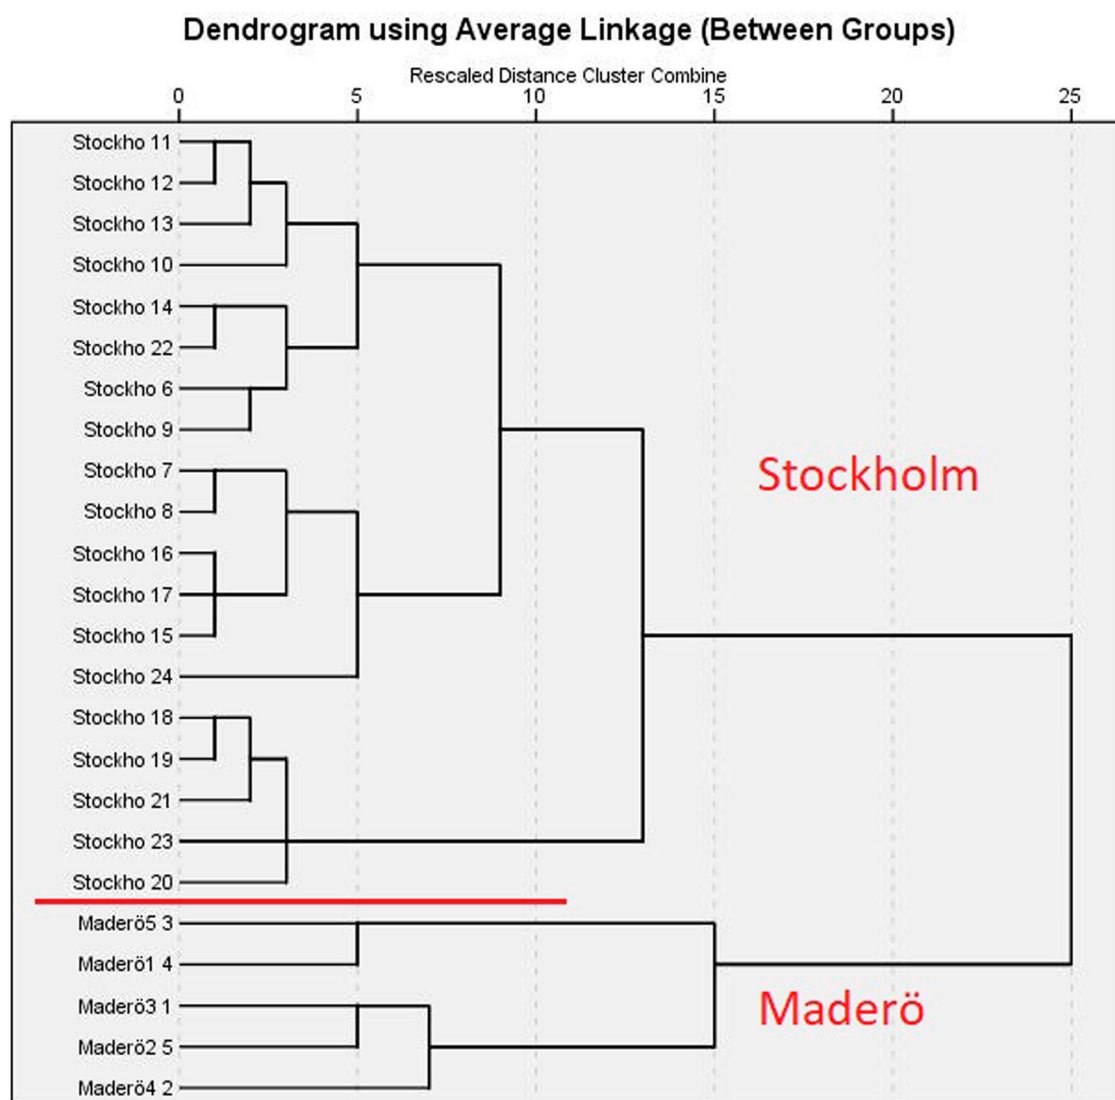
**Figure 13.** The samples Maderö1 and Maderö5 have the same chemical composition. None of the five samples from the wreck have any similarities with ceramics from the Stockholm region (Torbjörn Brorsson).

The samples were also compared to reference material from other parts of Sweden, Denmark, The Netherlands, Germany and Poland. Of these, the only matches are from northern Germany. Samples 1 and 5, paired together, match a sample from Büssow

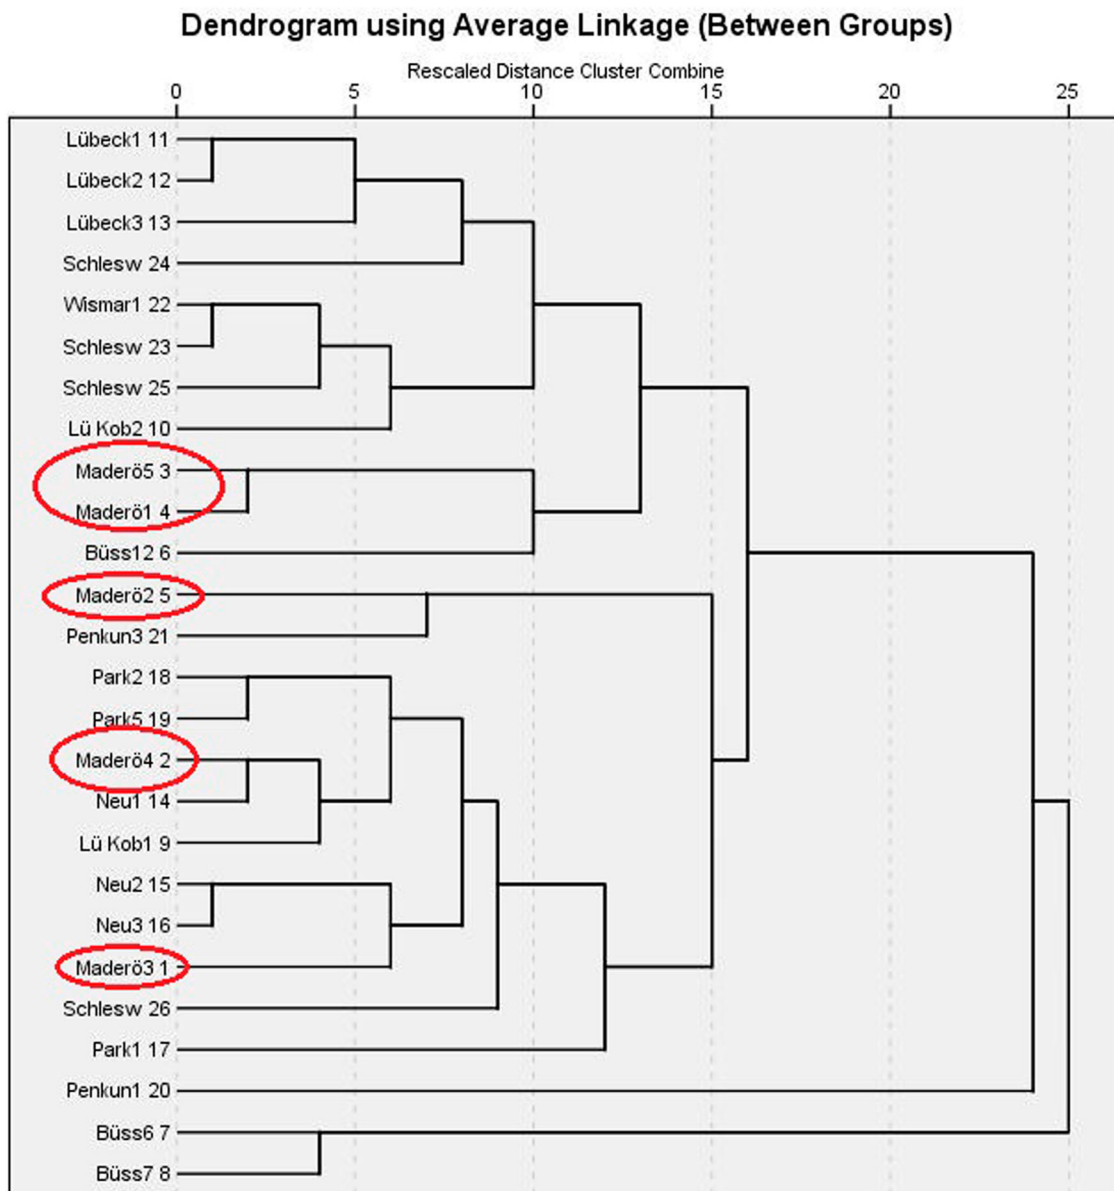
**Figure 14.** The bricks from the Maderö wreck have similarities with material from pottery and bricks from north-eastern Germany (Torbjörn Brorsson).

in Mecklenburg-Vorpommern in north-eastern Germany (Figure 14). Sample 2 corresponds with a sample from Penkun, in the vicinity of Büssow in Mecklenburg-Vorpommern. Samples 3 and 4 are similar to samples from Neubrandenburg, *ca* 60 km south of Greifswald in north-eastern Germany, also located in Mecklenburg-Vorpommern.

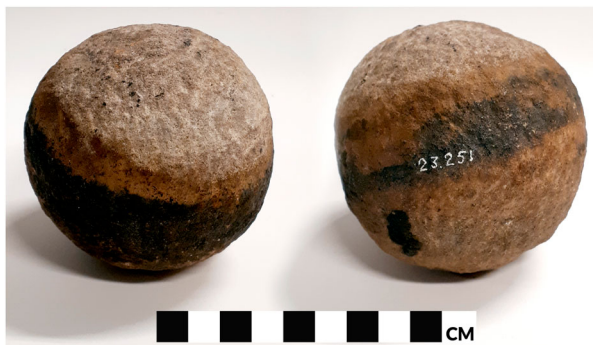
**Figure 15.** Two views of the stone shot from the Maderö wreck in SMTM's collection. Note the brownish colouring that surrounds the entire ball. The calibre is approximate 78 mm (Susanna Alleesson-Nyberg/SMTM).

One single stone shot is preserved in the collections of the SMTM (Figure 15) and thus accessible for closer examination. It consists of a rock which is carved into a nearly perfect spherical shape, with a calibre of around 78 mm. Without information concerning the archaeological context where the stone shot were found aboard the ship it is difficult to be certain whether they were part of the cargo together with the bricks and tiles or if they derive from the ship's own artillery.

There is a brownish band that looks similar to rust around the entire outer circumference of the stone shot. The surface of the stone shot is darker in colour on one side of this band and lighter on the other. In order to obtain clues as to what might have caused these different colourations, they were analysed at the Archaeological Research Laboratory, Sweden, using a portable X-ray fluorescence detector (XRF).

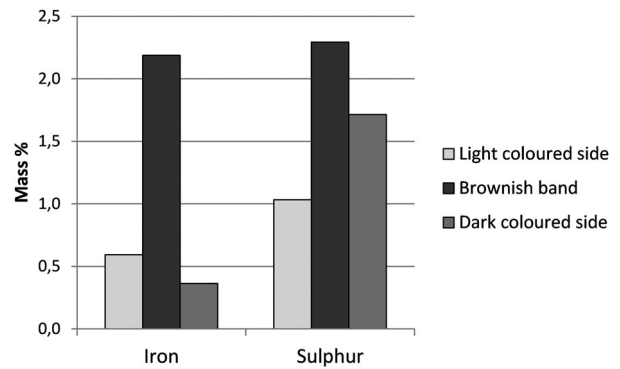
**Figure 16.** Means of the relative XRF signals (mass percent) recorded on the differently coloured surfaces of the cannonball (Sven Isaksson).

Three different spots on each of the three different coloured surfaces were analysed and the means of the detected elements were calculated and compared. The brownish rust band and the dark-coloured side gave a distinctively lower signal from silicon than the light-coloured side. This indicates that the coloured parts of the rock are indeed covered in a surface of a different composition since the silicon most probably reflects the minerals of the rock. The XRF signals from two elements in particular stand out in the analysis: iron and sulphur (Figure 16).

The distinctively higher iron signal from the surface of the brownish band suggests that it is indeed traces of contact with metal iron. However, the conditions for preservation of iron are very poor at the wreck site. For instance, the iron nails and rivets that attach the strakes of planking together have all corroded away. The question is what kind of now totally corroded iron artefact could have left these traces on the stone shot? One possible explanation is that the rust is the remains of an attached iron and that it could have formed a part of an early bar or chain shot. However, we have been unable to find parallels to such shot made of stone. But perhaps there is another explanation?

Rust is a mixture of iron oxides, hydrous iron oxides and iron oxide-hydroxides, reddish to brownish in colour. Since the brownish band on the stone shot is also the surface highest in sulphur it is very likely that ferrous sulphides contribute as main components. Iron sulphides are formed in low-oxygen, low-pH environments; they are black or brown in colour and are insoluble in water, explaining why this band has been preserved. The varying signal from sulphur between the different surfaces is also revealing. Sulphides may form naturally in low-oxygen zones of lakes and oceans through sulphate-reducing bacteria. But if that would have been the cause here, one would expect the sulphur to be evenly distributed over the surface of the stone shot. In this case, one side – the dark-coloured side – shows a distinctively higher sulphur signal than the light-coloured side.

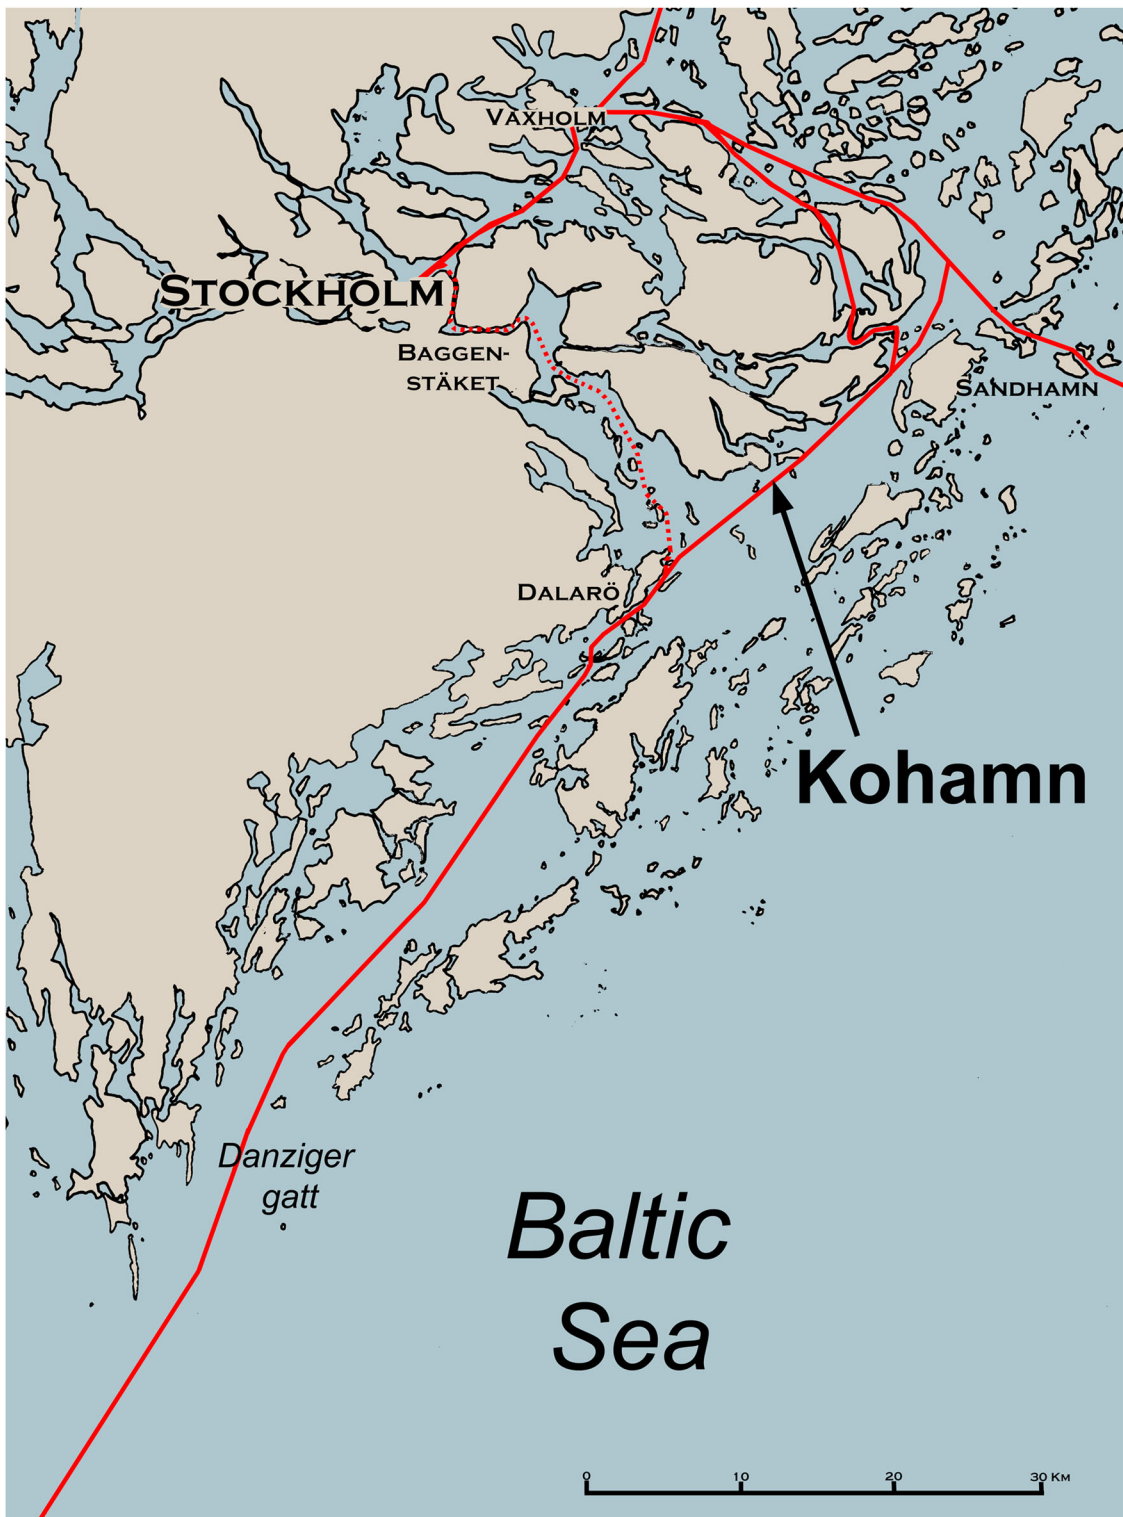
**Figure 17.** A ship sailing from Lübeck would enter the archipelago from the south through the Danziger Gatt strait. Small vessels could use the shallow passage through Baggenstäket whereas a large vessel – such as the Maderö ship – would have to make a U-turn left and enter Stockholm from the north. Kohamn, where the ship sank, is a natural harbour basin along the sea route (Niklas Eriksson).

Ships heading for Stockholm from Lübeck or any other departure in the Southern Baltic entered the archipelago through the Danziger Gatt strait. Small vessels could reach the city though the shallow passage through Baggenstäket, whereas larger vessels – like the Maderö ship – would have to make a U-turn around the archipelago and approach Stockholm from the north. The Dutch diplomat Antonis Goeteeris described it as follows: 'you will have to circumnavigate the entire compass in order to sail out or in among the islands' (Figure 17) (Goeteeris, 1917, p. 187, author's translation; see also Eriksson, 2021b, p. 20; Eriksson, 2022, p. 119). It almost goes without saying that it is rare to have fair winds to transport a square-rigged cargo vessel on such a manoeuvre. This is why the natural harbours, such as Kohamn, formed by sheltering islands, are so important.
