Vasa föremål

Caulking
Mallet

18460

Ship's Carpenters Tools
18460
11 Nov 2013 EAA

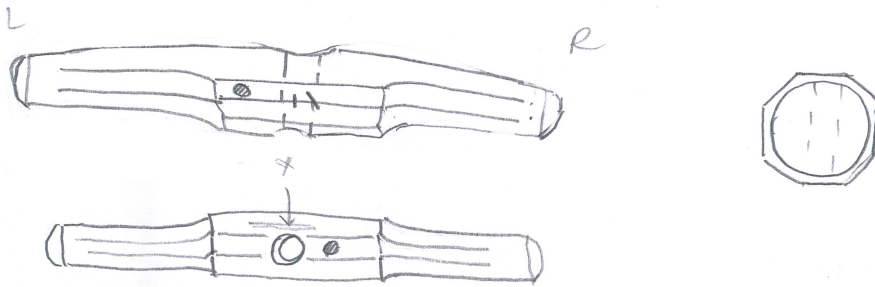
Skiss (see second sheet)

Skador/damage some loss on underside @ "X" (around hole for handle) original surface largely intact; mushrooming/grain compression @ ends indicates mallet had been used.

Kommentar/comments blind holes @ Right end modern, artifacts of tagging. two plugged blind holes on face & bottom. Purpose not immediately apparent.

Visible evidence that the ends of the mallet had metal rings to prevent splitting during use; have completely corroded, no extant metal

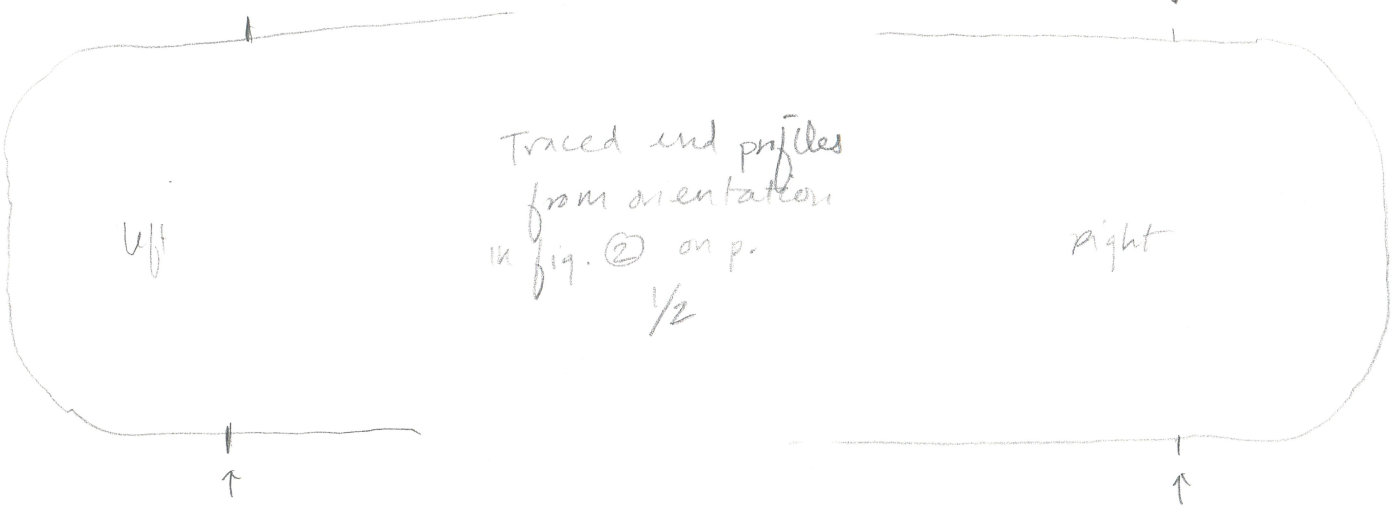
compression from nwg starts here
