Vasa föremål

ruler

27686

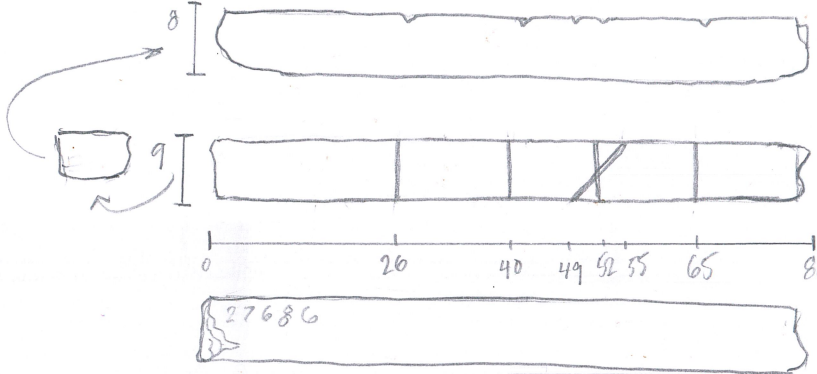
Skiss

Skador/damage Fragment; broken @ both ends, probably along marks cut to denote measurements. Freeze-dried.

Kommentar/comments as noted, probably piece of a longer ruler - both ends appear to have broken along marks cut to denote measurements

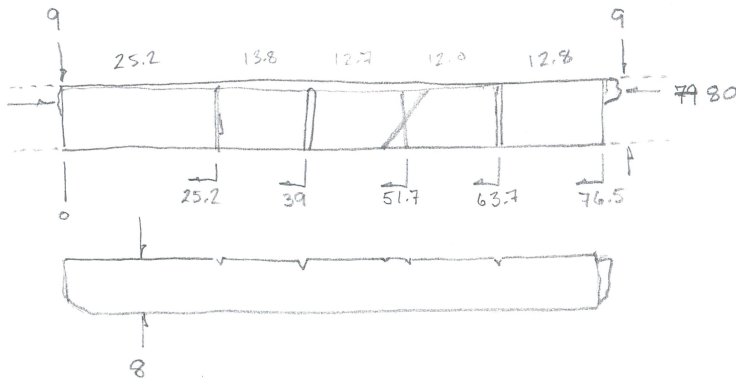
27686 FOUND UNDER FRAME WHEN BOTTOM PLANK REMOVED, c. BEAM 18-19
 MATERIAL: PINE CONDITION: BROKEN AT BOTH ENDS

AVERAGE INTERVAL ($\frac{1}{2}$ INCH): ~~12.9~~ 12.75mm
 CLOSEST TO ENGLISH OR DUTCH INCH
